UPPER FULTON DAM

INVENTORY NO NY 408

PHASE I INSPECTION REPORT
NATIONAL DAM SAFETY PROGRAM.

Upper Fulton Dam (Inventory Number NY-408).
Oswego River Basin, Oswego County,
New York. Phase I Inspection Report.

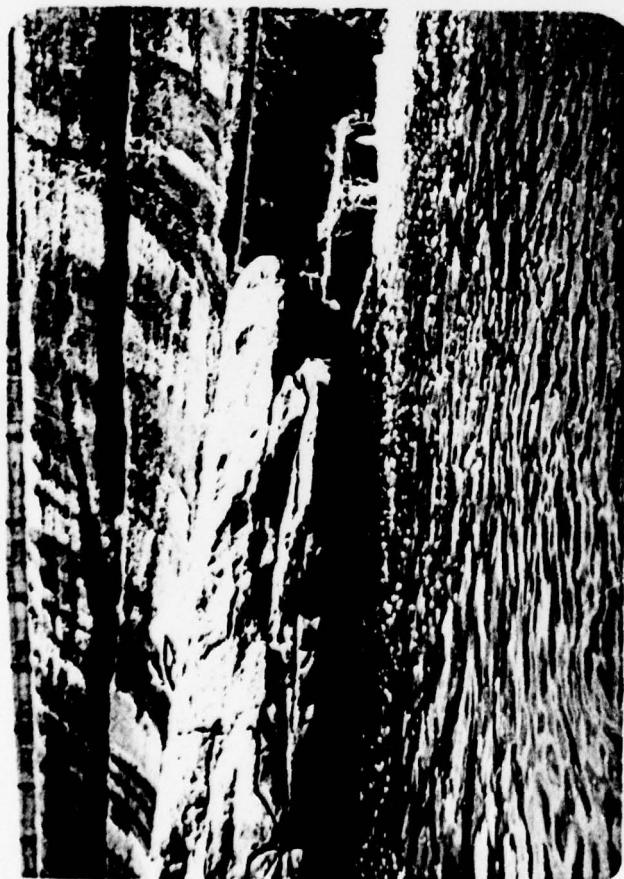
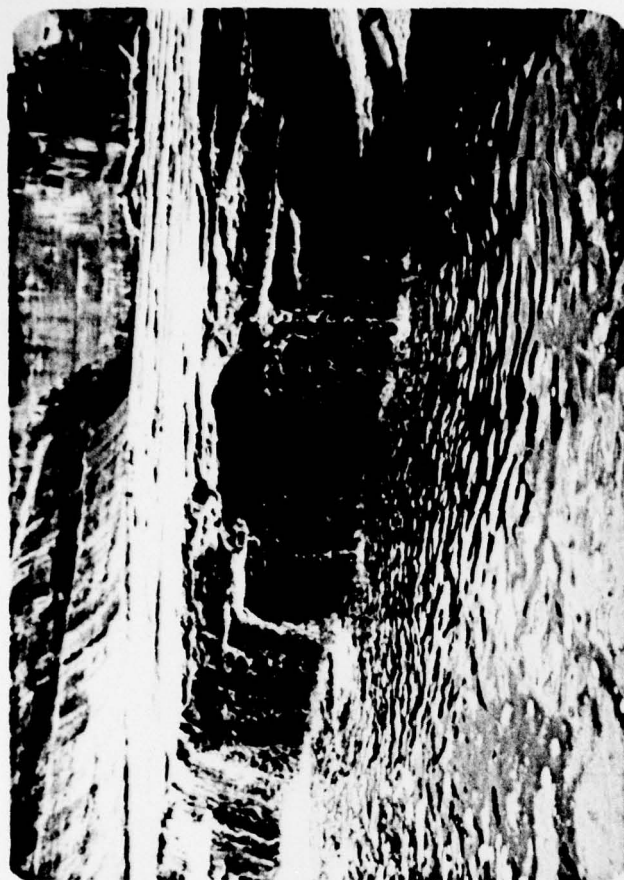
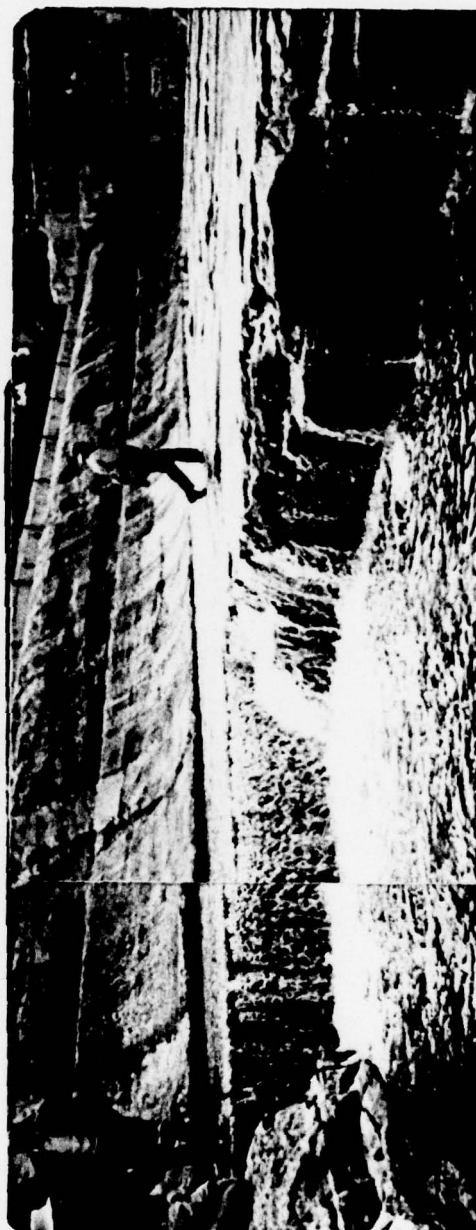
1. Closeup of deteriorated sandstone bedrock at base of spillway. An eight foot wide by two foot thick concrete thrust block is located here. Some undermining is suspected below concrete block. Severe undermining can be seen as shadowed areas of bedrock.

The river's bedrock surface immediately downstream of the dam and tainter gate structure forming the western segment of the dam facility was observed to be jointed and layered. Loose blocks of bedrock lie on the river floor. Erosion and undermining of the upper rock occurred across much of the river spillway area with the erosion/undermining working back dangerously close to the dam structure at one location about mid-length of the main dam/spillway section and at another location near a tainter gate pier.

- c. Repair the subsurface condition under the dam and below the dam. Grouting to improve the dam's subsurface condition may be required.
 - d. Repair the stone masonry river side wall of the east bank generator station to eliminate leakage and seepage. Repair the concrete capping on top of the wall.

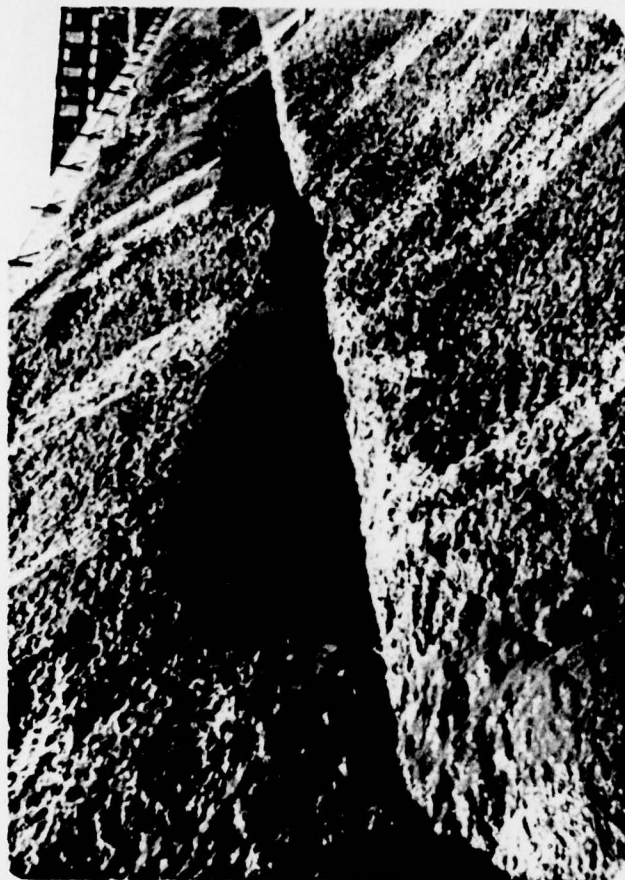
2. View of spillway crest with pool drawn below crest. Advanced deterioration of concrete surface has taken place across the entire spillway. Some seepage is evident between construction joints.

Design drawings available for review, dated 1909 and included in Figures 2-16, indicate the present main dam section is composed of a masonry core (presumably an older dam structure at this location) and a concrete cover (presumably utilized to increase the height and section of the original dam to obtain the present configuration). At this time, virtually the entire downstream dam face has experienced deterioration, some quite extensive. A horizontal joint at about the dam's mid height and extending the complete length of the dam (probably a construction joint) is widening in the facial zone from deterioration and erosion of the concrete. Seepage occurs through this joint.

- a. Repair the spillway system. The deteriorated concrete should be removed prior to resurfacing the spillway.
 - b. Repair the corner of the main weir and side channel spillway.

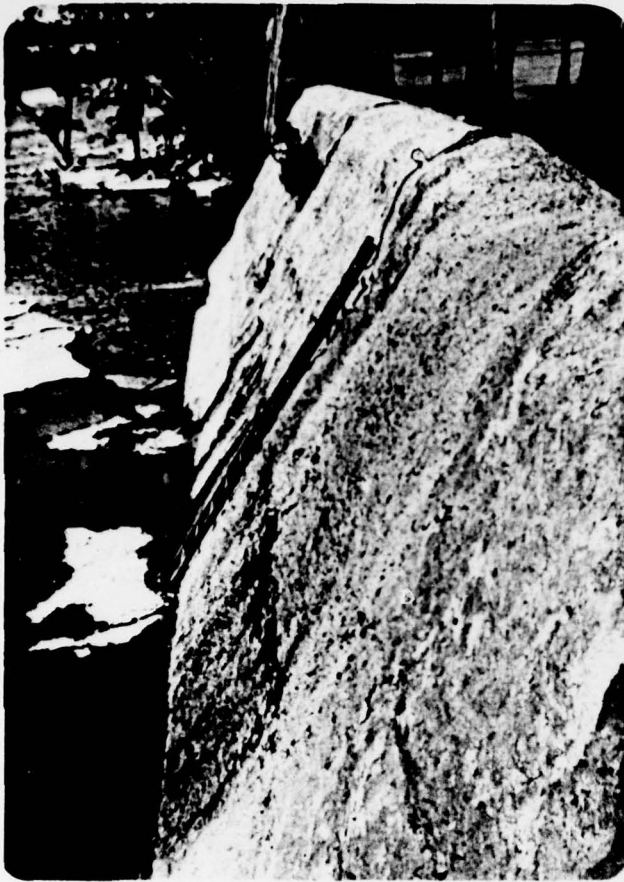
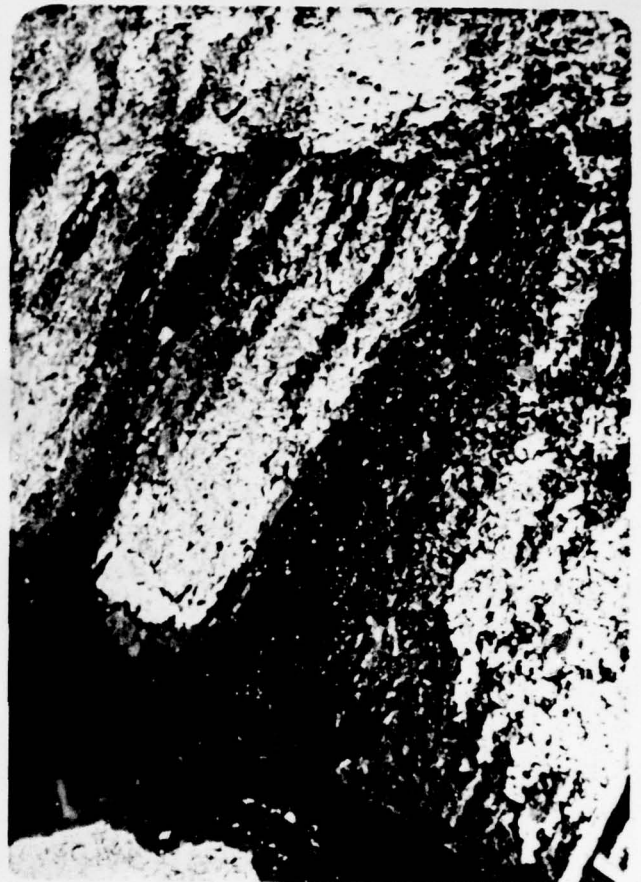
5. Spillway section parallel to river channel flow and in front of east side of hydropower forebay area. Notice severe deterioration of surface, haunch in top of spillway due to deterioration, and notice seepage through construction joint.

At the east end of the main dam/spillway section, the concrete and masonry corner structure (used to join the main dam to the short transverse section leading to the power plant forebay) is severely deteriorated and undermined. The concrete dam/spillway section leading to the forebay is experiencing surface deterioration but appears stable.

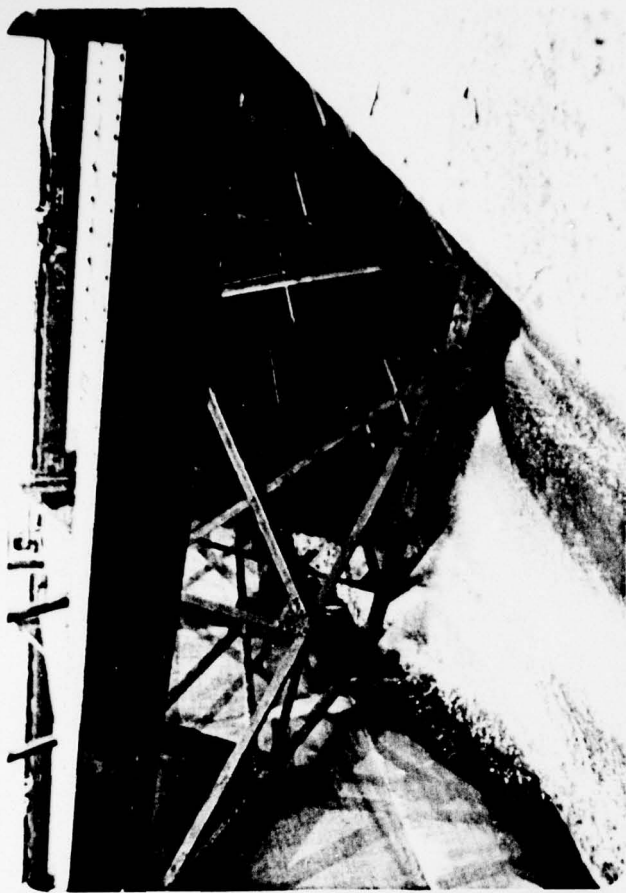
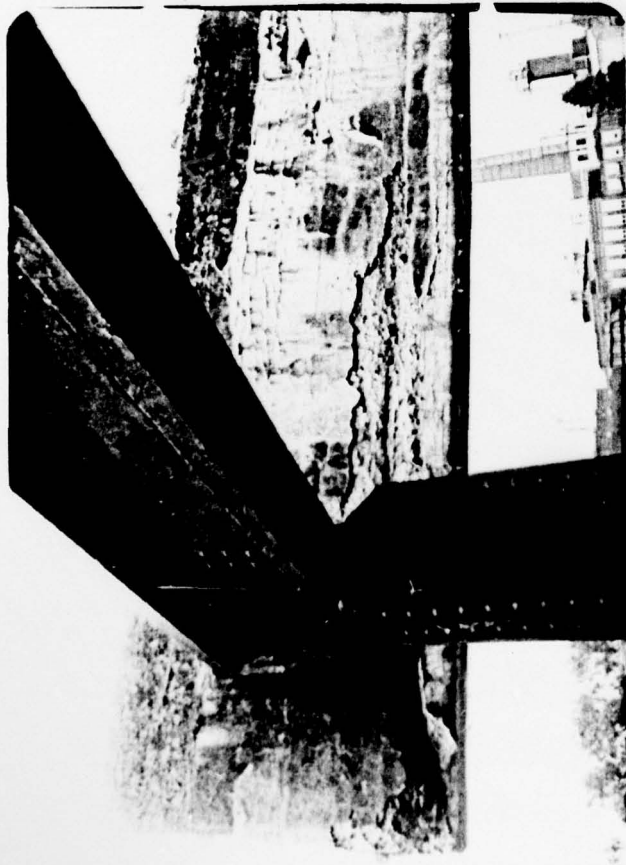
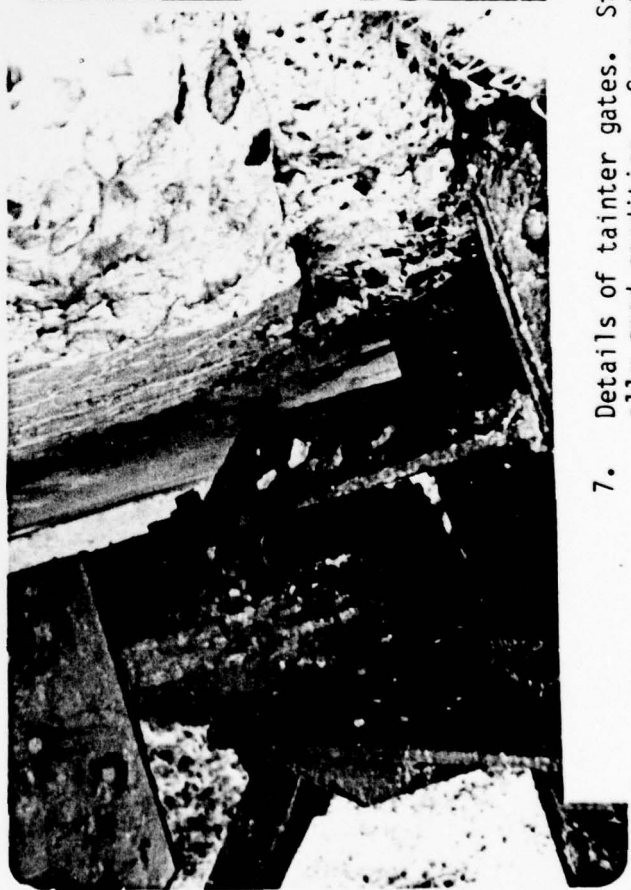
7. Details of tainter gates. Structural steel in generally good condition. Concrete piers and counterbalances show deterioration. Gates controlled with manual rack and pinion device.

The tainter gate structure is in operating condition. These gates were operated in order to reduce the level of the upstream pond for the second inspection. The structural steel is in fair condition throughout. It is in general need of painting. The concrete is in a deteriorated condition. Surface spalling is prevalent throughout the structure. The operating mechanisms are manually operated and consist of worm gear operators which turn a pinion gear which engages a rack for raising and lowering the tainter gates. Deterioration of the bedrock foundation in the downstream channel has taken place to a point approximately 2 feet downstream from the bulkhead between the second and third gate from the west end of the structure.

- f. Repair the concrete at the tainter gates, or replace the gates.

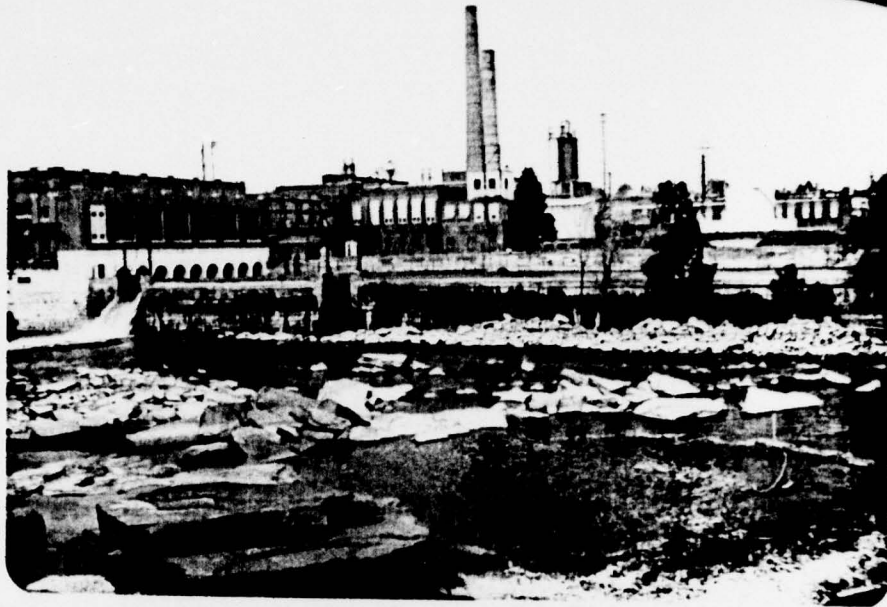
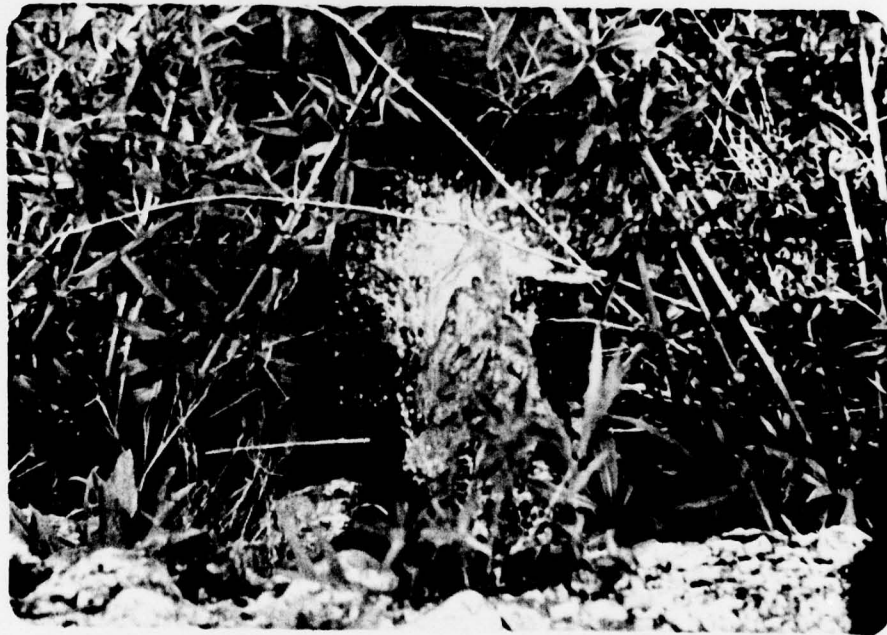
8. View of east side of hydropower forebay wall. Seepage can be observed along wall. Closeup shows seepage discharge from wall at a location directly below twin smoke stacks.

Visual inspection reveals spurting leaks along the wall which separates the forebay of the easterly power generating station from the main river channel. This wall is generally in poor condition with seepage noted along the surface. The concrete surfaces of the main spillway and side channel spillway are in deteriorated condition. Severe deterioration has taken place along horizontal and vertical joints. The foundation of the dam shows some sign of undermining in the bedrock. This condition could worsen with time. The tainter gates are in generally good condition, although surface spalling of the concrete is prevalent throughout the structure. No major deformation of the alignment of any of the structures was noted in the visual inspection. The tainter gates and control structures are in operating condition. The sluice gates controlling the flow into the forebay of the easterly power station are inoperable and severely deteriorated.

The power plant and its forebay are located on the downstream side of the dam/spillway structure. A layed-up stone wall separating the forebay and river appears structurally stable, but through-the-wall leakage, some extensive, occurs at several locations.

- e. Repair the sluice gates controlling the forebay of the east bank generating station. (Gates must be operable in order to accomplish item #d above.)
